# The addition of artificial macrophytes in an attempt to improve water quality at Barton Broad, Norfolk, England

Kelly A.

*Broads Authority, 18 Colegate, Norwich, Norfolk NR3 1BQ, UK*

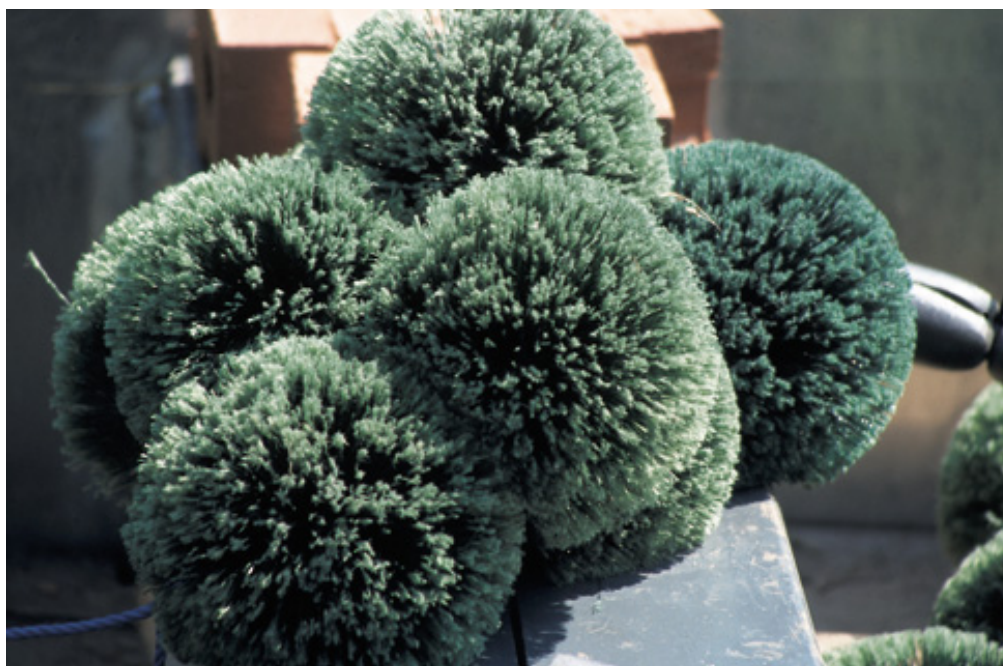
**Photo 1.** Bunches of Italian cobweb brushes used as artificial macrophytes in Barton Broad.

Mesocosm 1 - 14,000 'Italian cobweb brushes' (Photo 1) were suspended in bunches on ropes hung from posts installed in the water. The purpose of the brushes was to mimic native

plants which provide zooplankton refugia (e.g. rigid hornwort *Ceratophyllum demersum*). Fish were removed by electro-fishing; all were identified, counted and measured before being released outside the mesocosm.
